Lake Mary Ronan

GENERAL INFORMATION

LAKE METRICS SUMMARY AND SCORES

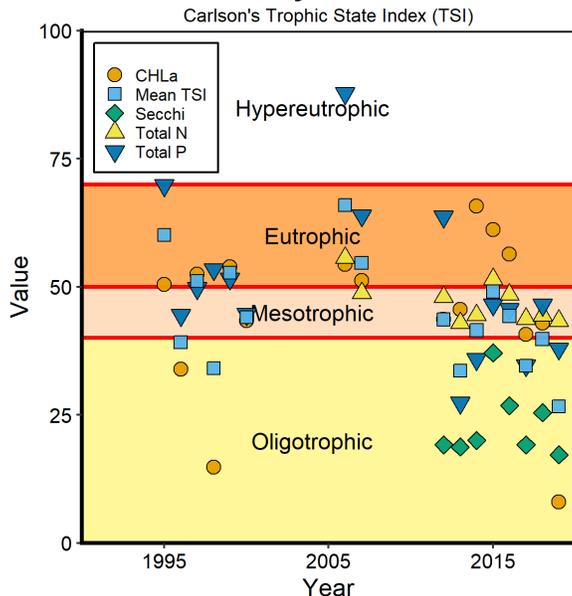
Lake Mary Ronan, East

Metric	Score	Description
Cold-water fish habitat	Medium	Temperature profiles indicate that Mary Ronan East has been within the avoidance threshold range for salmonids at depths of up to 6 meters during August. Oxygen profiles show that Mary Ronan East has been between avoidance and anoxic concentration thresholds for salmonids at depths greater than 6 meters. Anoxia has been observed at depths greater than 8 meters. Temperature profiles indicate that Mary Ronan West has been within the avoidance threshold range for salmonids at depths of up to 6 meters during July and August. Oxygen profiles suggest that Mary Ronan West has been between avoidance and anoxic concentration thresholds for salmonids at depths greater than 8 meters. Anoxia has been observed at depths greater than 9 meters.
Nutrient Levels	High	Lake Mary Ronan west and east continue to rank highest among large lakes for total phosphorus, total nitrogen, and chlorophyll (a) .

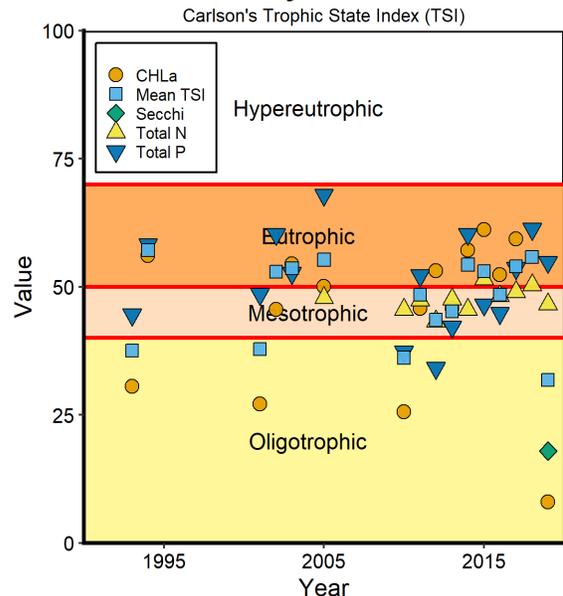
Lake Mary Ronan, West

Nutrient Trend	Consistent-Increasing	There is no apparent trend for Lake Mary Ronan East but Lake Mary Ronan West appears to be increasing in nutrients since 2011.
Trophic Status	Meso-Eutrophic	Carlson's Trophic Index trend shows Lake Mary Ronan is consistently meso-eutrophic.
Dreissenid Colonization Potential (Calcium)	Low	The lake's 2010, 2011, and 2016 average calcium concentration was 16.2 mg/L classifying it as a low risk for zebra mussel colonization. The 2012 alkalinity level was reported at 54 mg/L.
Known AIS infestations	None	In 2011, a EWM survey was conducted at many locations including the public access site yielding no suspect results. Additional surveying is recommended based on nutrient levels, lake size, recreational use, and the amount of macrophytes observed during the initial survey.
